## Heritage Statement for: Proposed Repairs and Alterations at Orford House Social Club

*Prepared by: P Bell BSc MCIOB*

*Date: 29 July 2024*

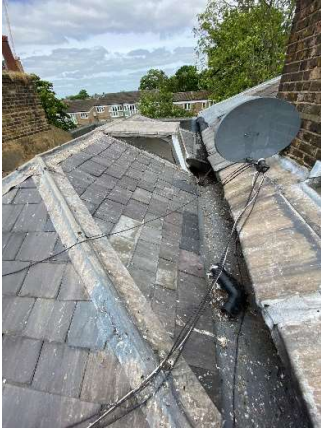
The original lining to the parapet gutter is assumed to have been lead which was later replaced with mastic asphalt. We considered returning it to lead but the detailing required to achieve the sufficient falls to the existing outlets are not practical and would require a high level of maintenance and clearing in the future. The choice was then between modern day membranes, and we concluded EPDM offered the best in terms of longevity, impermeability and future maintenance and clearing costs. The original lathe and plaster soffit to the underside of the west hip of the main roof will be replaced with a modern fire rated external grade board such as 'Magply' or similar, fitted with a strip ventilator and then paint finished.

<i>Parapet gutter lining detail</i>	<i>Lathe and plaster soffit to west hip of main roof</i>	<i>Deteriorated stonework to west wing</i>

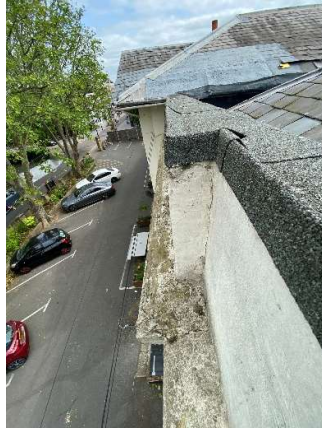
The stone cornices to the original building are suffering localised deterioration. The concrete cornices to the extension have failed. Water ingress via the joints has resulted in extensive water damage to plasterwork in the games room. An attempt to rectify the problem has been carried out in the past when bitumen felt was used to cover the top surface of the mouldings. This appears to have been only temporarily successful and the problem continues to the extent that it will soon start to affect the ends of the structural steels. The reason the cornice has failed is due to detailing. Each length of concrete is butt jointed rather than utilising a traditional saddle joint which would have protected against this problem.

Our proposals are to carry out repairs and sectional replacement where necessary to the original stone cornice. We then propose to use traditional lead detailing to provide protective covering to the tops of all the cornices. The technique is recommended in older building books (see for opposite from Jaggard & Drury, 1923) and has been successfully employed on the restoration of the similarly designed Elizabeth Gaskell House, 84 Plymouth Grove, Manchester (see below).

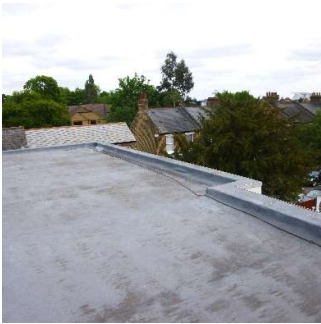
A full internal and external survey of these roofs revealed that the slates and gutters have deteriorated beyond a point of effective and economic repair. One of the hip rafters and the front wall plate to the west wing have decayed due to long term persistent water ingress and will require replacement.

<p><i>Rotted end of hip rafter below west wing roof</i></p>	<p><i>East wing and extension roof</i></p>	<p><i>Reinforced liquid membrane poured over original three layer bitumen felt</i></p>

To prevent further failure of the roof framing our proposal is to remove all slates, remaining leadwork, sarking boards, asphalt membrane, gutter boards and brackets along with the collapsed lathe and plaster soffit below main roof. All carpentry repairs can then be carried out which will include new timber bracketing and boarding to the parapet and hidden gutters. The roof slopes will be covered with Welsh slates from the Blaenau Ffestiniog quarry and new leadwork to match the existing hip, ridge, eaves and hidden gutter detailing.

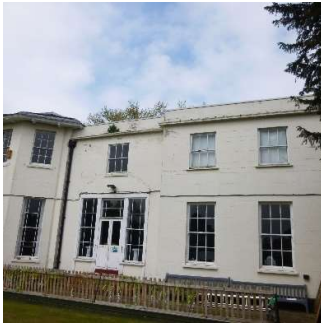
Horizontal cracking to the extension rear elevation cavity walls indicates wall tie failure. This is presumed to be due to the water ingress is mentioned above. Until recently cavity wall ties were generally made of galvanised steel. When moisture is allowed to enter the cavity, the ties can corrode and expand causing the brick joints to lift which in turn presents as a horizontal crack at regular intervals. We will employ standard techniques to open the cavity and replace the affected galvanised ties with stainless steel ones. The brickwork and render to then be reinstated to match the original

<p>East wing and extension rear elevations</p>	<p>Detail showing cracking to render and possible cavity tie failure below concrete cornice</p>	<p>Rear elevation looking east with west wing parapet in foreground</p>
