## Heritage Statement for: Proposed Repairs and Alterations at Orford House Social Club

*Prepared by: P Bell BSc MCIOB*

*Date: 29 July 2024*

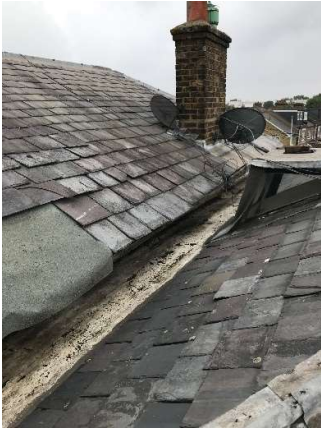
A full internal and external survey of these roofs revealed that the slates and gutters have deteriorated beyond a point of effective and economic repair. One of the hip rafters and the front wall plate to the west wing have decayed due to long term persistent water ingress and will require replacement.

<i>Rear elevation</i>	<i>West wing roof viewed from ridge of west hip end of main roof</i>	<i>Roof framing to west wing roof</i>

To prevent further failure of the roof framing our proposal is to remove all slates, remaining leadwork, sarking boards, asphalt membrane, gutter boards and brackets along with the collapsed lathe and plaster soffit below main roof. All carpentry repairs can then be carried out which will include new timber bracketing and boarding to the parapet and hidden gutters. The roof slopes will be covered with Welsh slates from the Blaenau Ffestiniog quarry and new leadwork to match the existing hip, ridge, eaves and hidden gutter detailing.

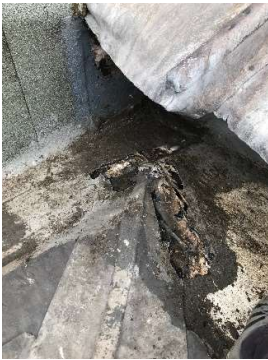
<i>Parapet gutter, west wing roof rooflight, west hip of main roof</i>	<i>Parapet gutter and front parapet wall looking towards west hip of main roof with gable roof over front pediment in the background</i>	<i>Chimney stack to west wing roof and decorative stack to annex building in background</i>

Our final alteration is to renew the west wing roof rooflight and lightwell. The existing is a modern single glazed dormer window fixed on top of what appears to be the original lightwell. The dormer is rotted beyond repair and is a constant source of water ingress. The original rooflight design is unknown. Our proposal is to replace the dormer with a double glazed top hinged rooflight which will give an inconspicuous, recessed, finish that directs natural light onto the landing below whilst remaining watertight then to rebuild the lightwell with insulated walls to avoid cold bridging from roof space. The works will include the repositioning of the roof access point from the lightwell to the kitchen where a new insulated hatch will be formed in the ceiling.

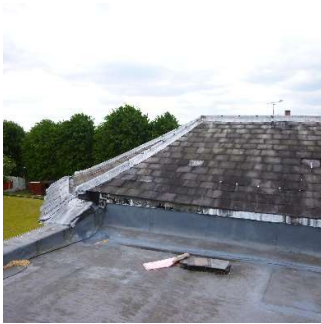
<p><i>Rotted end of hip rafter below west wing roof</i></p>	<p><i>East wing and extension roof</i></p>	<p><i>Reinforced liquid membrane poured over original three layer bitumen felt</i></p>

Opening up roof works merely to facilitate access to the repairs required to the parapet walls and cornice. Once these are completed the roof membranes will be reinstated to match the existing.

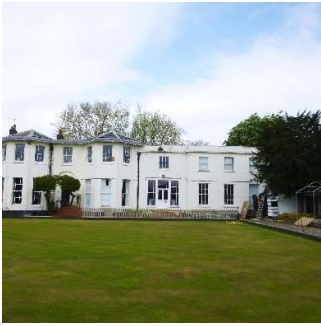
<p>East wing and extension rear elevations</p>	<p>Detail showing cracking to render and possible cavity tie failure below concrete cornice</p>	<p>Rear elevation looking east with west wing parapet in foreground</p>
